TECHNICAL NOTE

D-706

THE ARCTIC METEOROLOGY PHOTO PROBE

FEBRUARY—1962

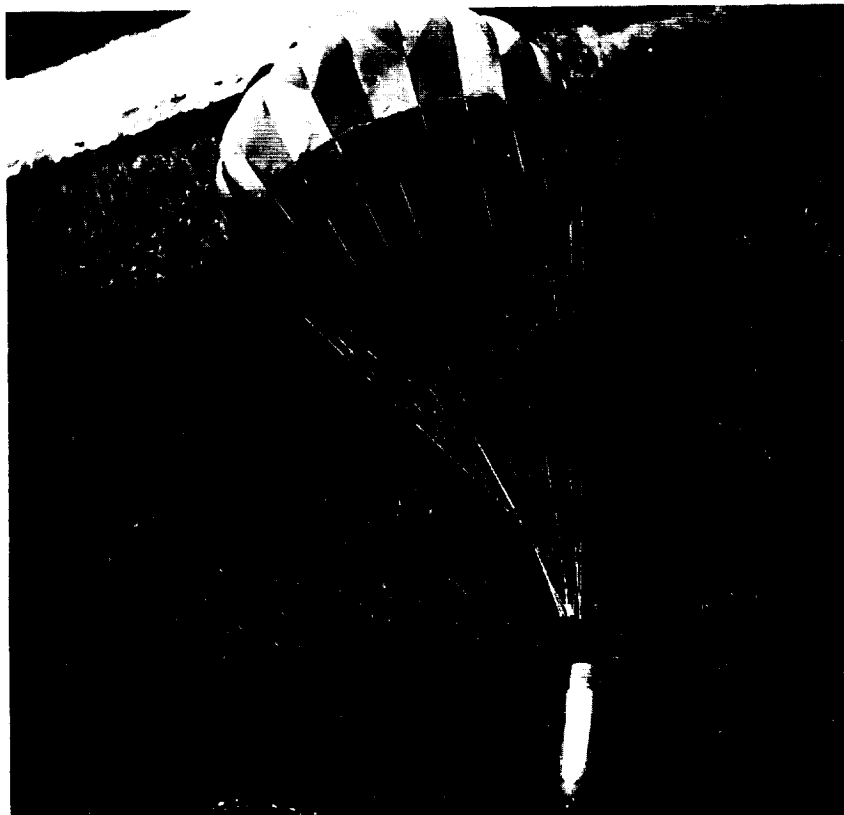
Figure 11 - Recovery of payload, NASA Flight 4.43

The payload impacted in an area not readily accessible on foot; the down-wash of the recovery helicopter's rotors was utilized to fill the parachute and drag the payload to more accessible terrain (Figure 11). In addition to the standard AMPP payload, this shot also carried a vibration test unit included at the request of the U. S. Naval Research Laboratory.

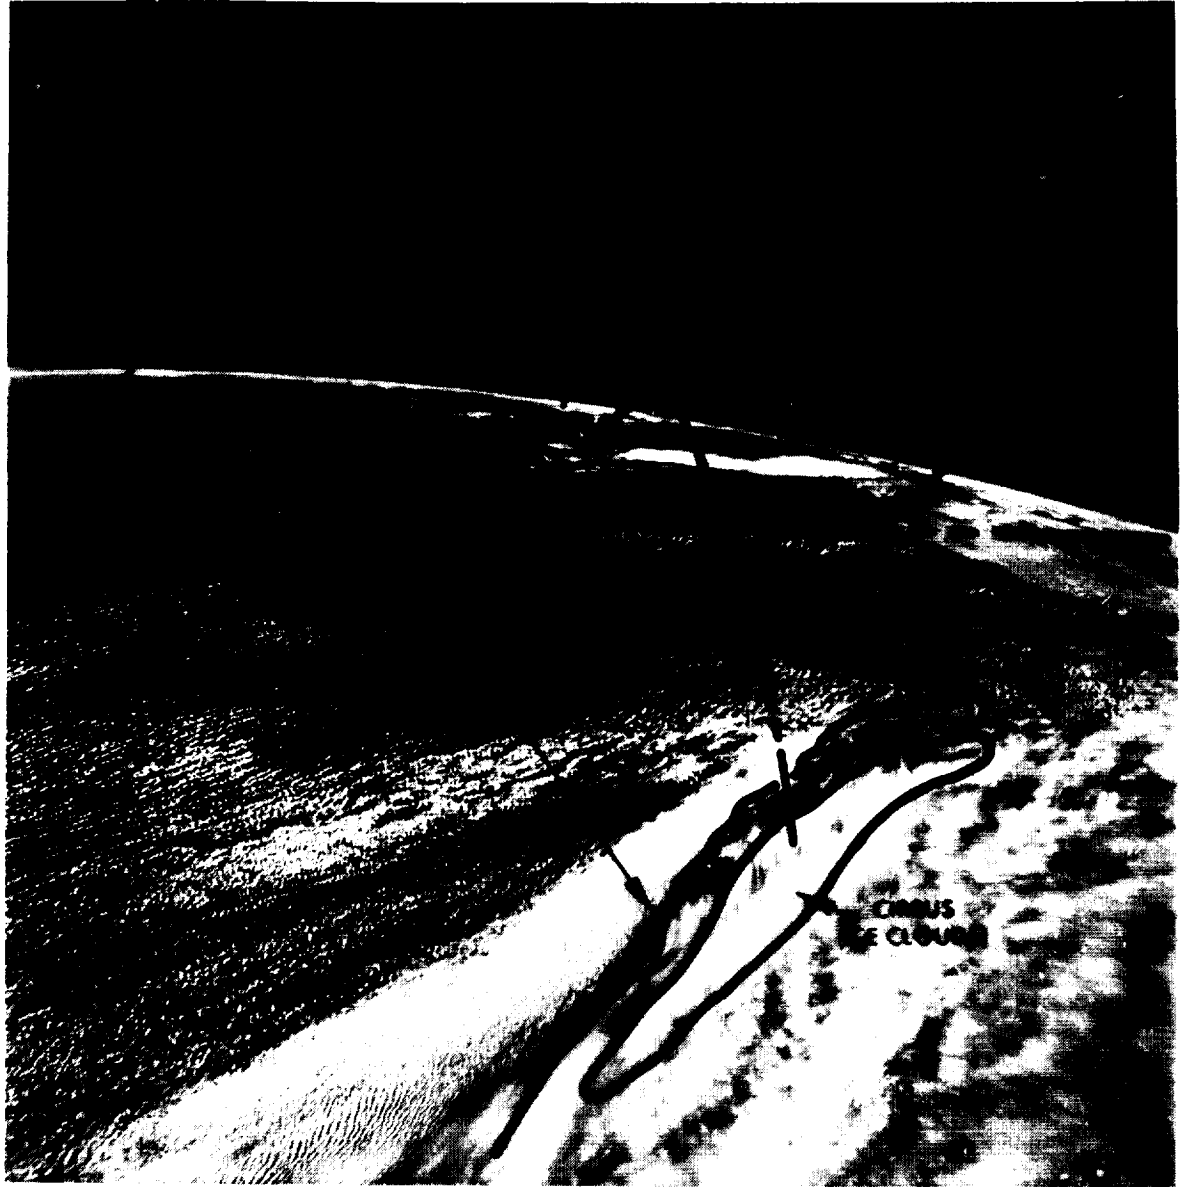
Figure 13 - NASA Flight 4.43, altitude 109 miles - infrared film

Infrared film produces the most useful high-altitude photographic results. The merits of color film were not clearly established due to overexposure. Black and white film (Figures 12, 14, and 19) does not provide as much detail as infrared film (Figures 13, 15, 16, 17, 18) and gives inferior cloud definition.
